Manhole Inspection Summary

Manhole # S33SS_031MH

Insp Date: **4/18/07 8:58 AM**

Location Address: **2654 MARYLAND AVE**

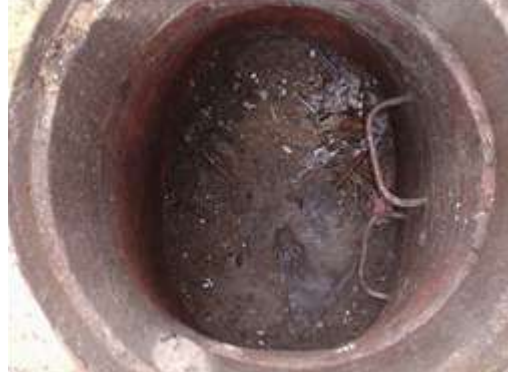
Top View

Corroded steps. Channel debris.

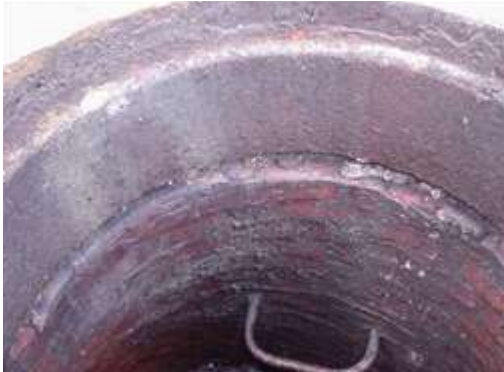
Defect

Frame leaks. Adjustment deterioration and infiltration. Corbel and Barrel infiltration - other side.

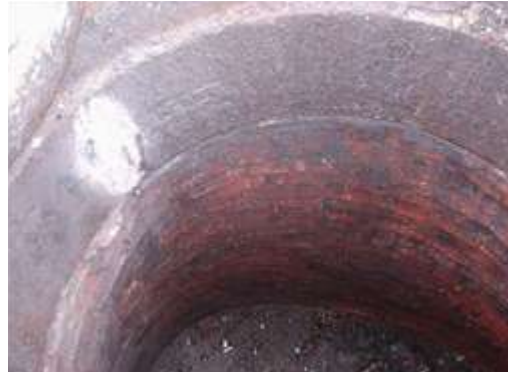
Defect

Frame leaks. Adjustment deterioration and infiltration. Corbel and Barrel infiltration.

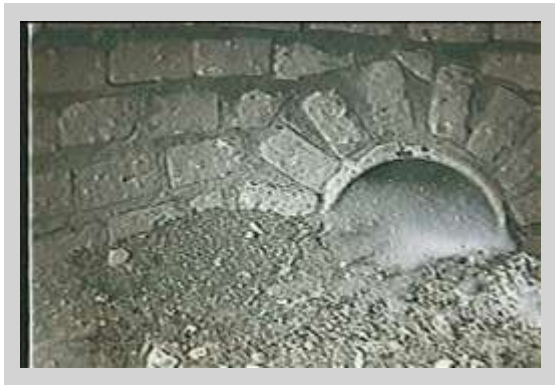
Barrel deterioration and infiltration.
